RAILWAY INVESTIGATION REPORT
R04T0008

MAIN-TRACK DERAILMENT

CANADIAN PACIFIC RAILWAY
TRAIN NO. 239-13
MILE 178.20, BELLEVILLE SUBDIVISION
WHITBY, ONTARIO
14 JANUARY 2004

Report Number R04T0008

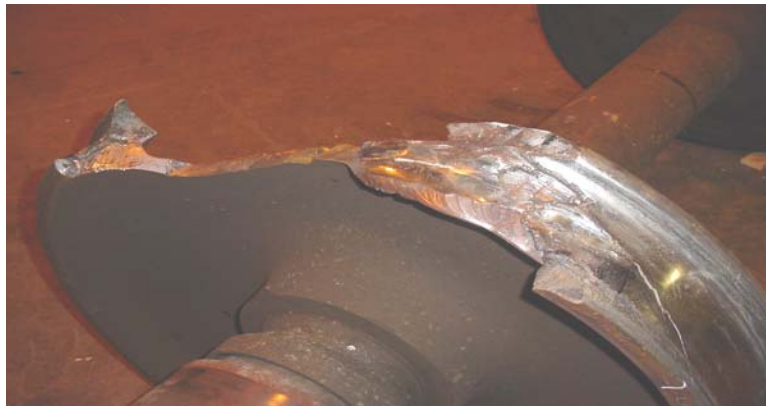
Photo 4. Broken wheel from car CNWX 111231

The broken wheel was a class “C,” cast, curved-plate wheel, built to design CH 36, and had been manufactured by ABC Rail in Calera in September 1995.
